Electrical faults in Trailer EBS systems (software status C1 .. D) of trailer emergency valve 971 002 802 0

This Information concern failures of signal transport between trailer emergency valve 971 002 802 0 and TEBS Modulator.

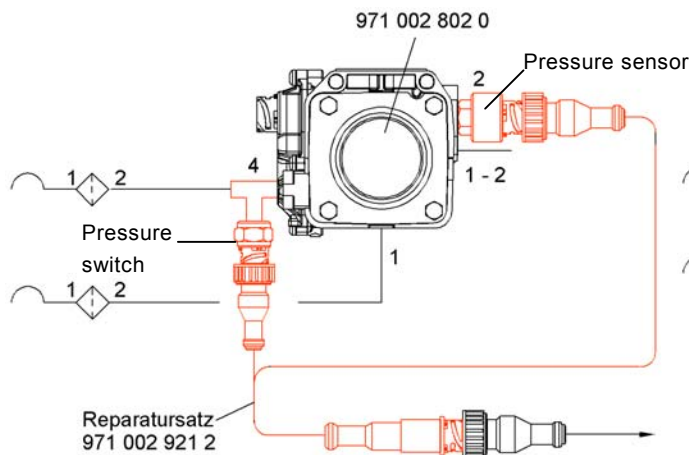
Repair Kit 971 002 921 2 with software status C1, C2

Repair kit 971 002 921 2 contains:

- Y-cable
- pressure switch
- pressure sensor
- bulkhead coupling
- counter nut
- T fitting

The fitted trailer emergency valve 971 002 802 0 is to be retrofitted with repair kit 971 002 921 2 or 971 002 922 2, depending on the software status of the TEBS modular.

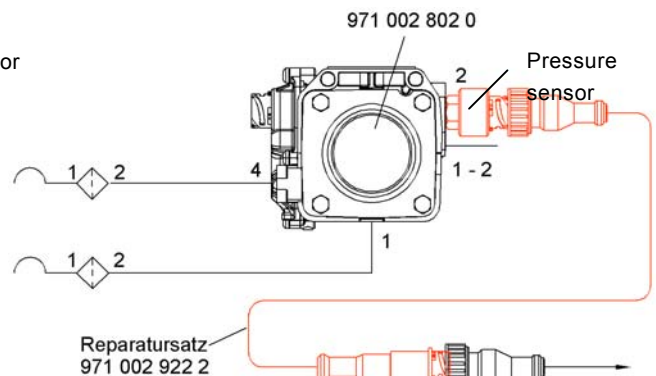
Repair Kit 971 002 922 2 with software status C3 and D

Repair kit 971 002 922 2 contains:

- cable
- pressure sensor

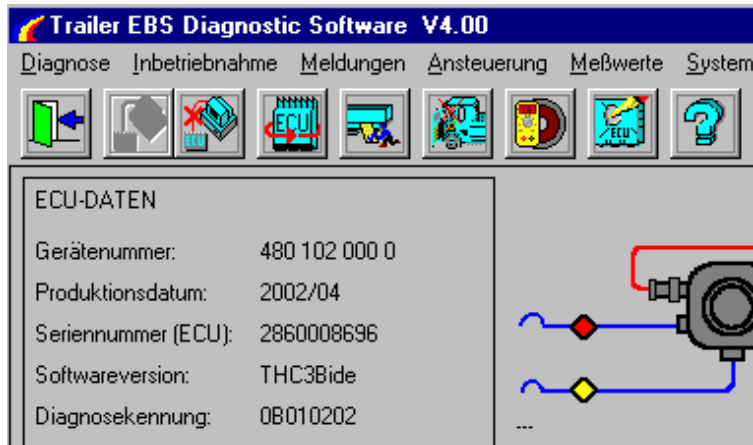
Where do I find the software status of the TEBS?

e.g. C3:
THC3Bide
