Product warning: Safety risk caused by poorly reconditioned brakes

The manufacturer Trucktechnic S.A., Herstal, Belgium offers reconditioned brakes of the WABCO PAN model range on the spare parts market.

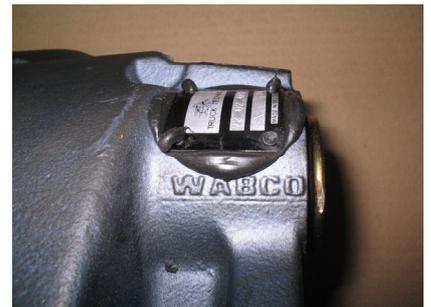
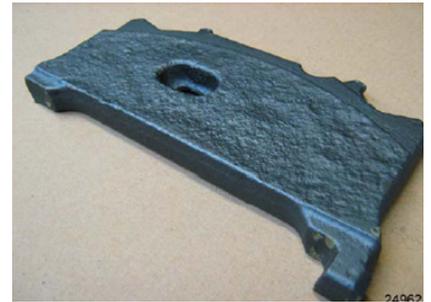
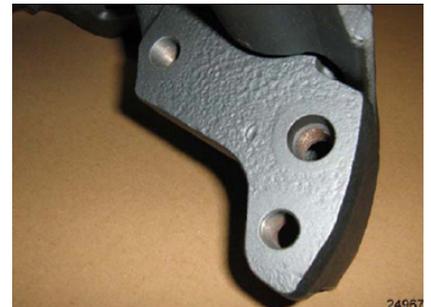
- The reconditioned brakes have Trucktechnic type plate.
- The bearing surfaces of the screw joints to the axle are painted (normally free of paint)
- Heavy traces of corrosion are discernible at times.

Defective, corroded or worn parts had not been replaced for example (see photos).

Figure:
Details of the specimen of
Trucktechnic

WABCO strongly warns against installing brakes from this supplier because tests have revealed deficiencies relevant to safety. It is very probable that these deficiencies can cause the brake to fail completely.

Because the deficiencies mentioned above indicate a consistently improper reconditioning process, it must be assumed that all products of this supplier have deficiencies relevant to safety.
