TESTED TAIL PROFILE FOR TAILGUARD TRUCK & BUS

Vehicle	USS	Creation Date	ECU File
Truck: MB Econic 6x2/4 ABS Body: Haller Lifter System: Zoeller	Level 1: 2x 15° Level 2: 2x 0°	Nov 2014	<u>Link</u>

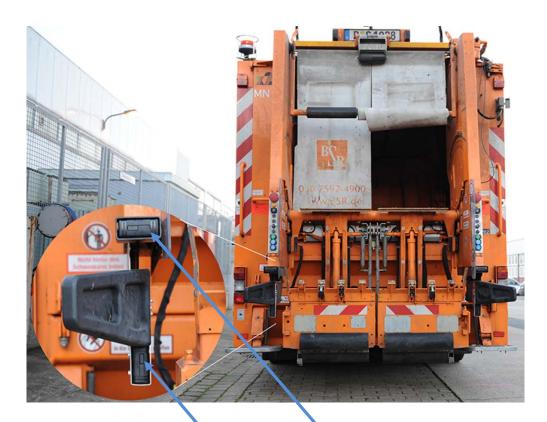
USS Level 1

USS Level 2

The specific position of the individual sensors can be read out in the Diagnostic software after opening the ecu file.

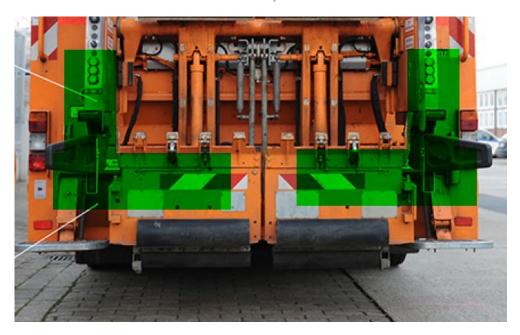
Green areas in the pictures correspond to areaes where objcts are recognized behind the vehicle. This is shown in two layers behind the truck:

In short-distance to the TailGURAD sensors layer:

Please use this information as a rough assessment only.

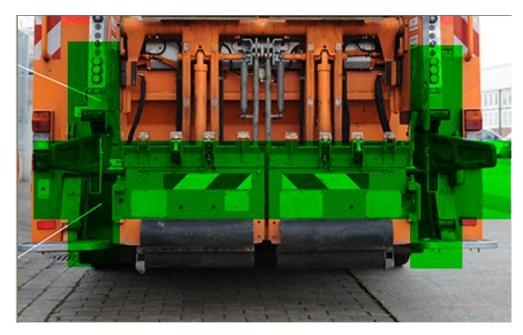
In a layer with 120 cm distance from the sensor layer
