Repair for the new generation of coupling heads with filter for trailers only with repair kit 952 201 920 2

The new generation of coupling heads with filter for trailers introduced in [Market Information 7016](#) (15 June 2007) must only be repaired using repair kit 952 201 920 2.

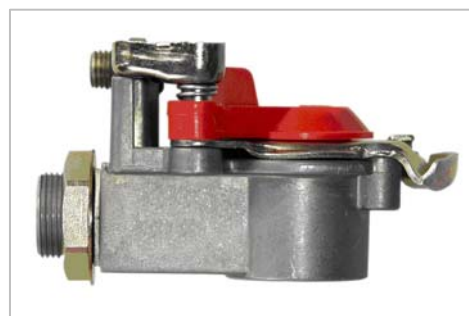
The following coupling heads are affected:

Description	Coupling heads New generation
Yellow, integrated filter	952 201 011 0
Red, integrated filter	952 201 012 0
Yellow, integrated filter, pressure test connection	952 201 013 0
Yellow, integrated filter, pressure test connection, connector	952 201 014 0
Red, integrated filter, pressure test connection, connector	952 201 015 0
Yellow, integrated filter, without hexagon nut	952 201 016 0
Red, integrated filter, without hexagon nut	952 201 017 0

Until this repair kit is made available, the entire coupling head needs to be replaced if a problem occurs.

The repair kit will include 2 sealing rings with different contours.

For repair it is essential that you note the contour of the installed sealing ring and replace it with the identical spare part from the repair kit.

Installing an incorrect sealing ring will cause a malfunction of the braking system.
